Analysis of Reject Part Adapter CN-235 (N70)

Sidik Permana¹, Cepi Saepudin², Usman Kustaman³, Ega Purwana⁴, Udin Kamarudin¹

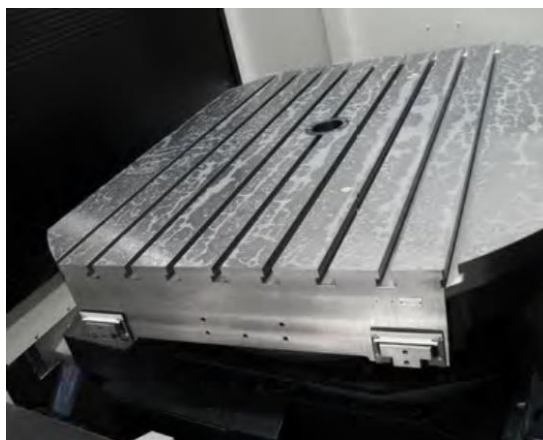
Fig.5 Pallet

The pallet is located on the pallet support, while the NC circular is located in the machining compartment of the machine. The pallet can rotate 1,400 x 1,600 mm. The usefulness of the pallet for storing materials or often referred to as the table holders of parts that are done by the spindle.

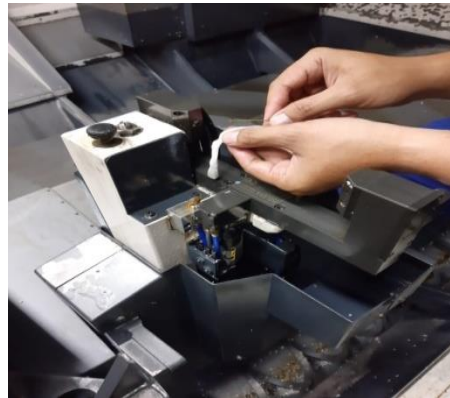
Fig.6 Laser Measuring Tool

The Laser Measuring or blum-micro tool is used to measure the length of the tool, the diameter of the tool, and enter the data into the tool data list. Tool measurements are carried out by moving the laser beam on the tool from above and from the side.

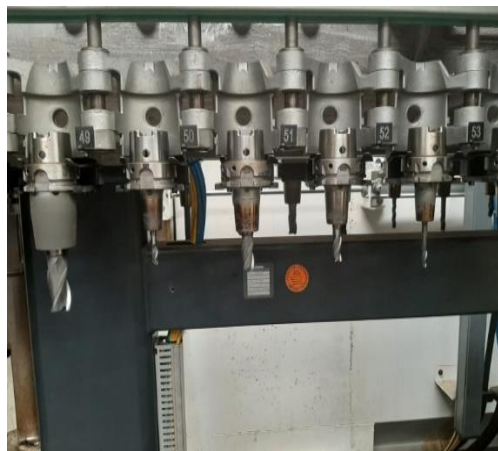
Fig.7 Magazine Tool

Magazine Tool is where the Cutting tool is stored in a CNC machine, all the Cutting tool that will be used in the process of forming workpieces is stored in the tool magazine and the amount in the magazine tool is 60 units. This magazine tool will move when the program is ordered by the operator

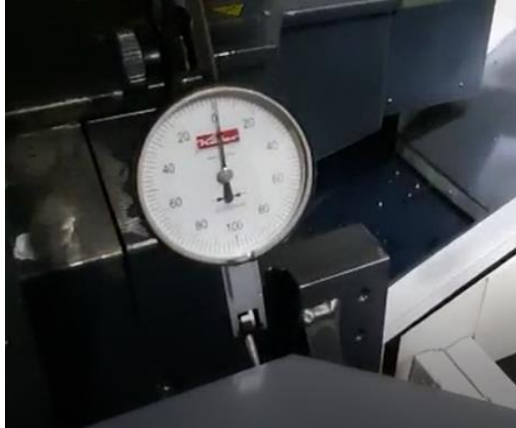
Fig.15 Dial Indicator to Zero Point

After knowing the results of the out tolerance of 12 microns, an inspection is carried out on the pallet table by setting the zero dial indicator position.

Axis C measurement results obtained the value of deviation of (-10) microns. This shows that deviations are still within tolerance.
