# Failure Analysis in High Pressure Feed Water Heaters and Method to Find the Defect in Tubes

**Abstract---** *The aim of this study is to analyze the causes of tube failure of the high pressure feed water heaters in thermal power plants and to find out the defective tubes in high pressure feed water heaters using simple and economical method. A feed water heater is used to preheat the boiler feed water in thermal power plant. Most of the feed water heater used in thermal power plant is shell and tube type. In this type of feed water heater, water flowing inside the tube and steam condensing in outside of the tube i.e., shell side. The source of heat used in high pressure feed water heater is steam bleed from the turbine. The high pressure feed water heaters are used to improve the thermodynamic efficiency of the cycle and also reduce the coal consumption of the thermal power plant. Sample of the failure tube were taken to analyze the causes of tube failure in high pressure feed water heater by visual inspection, using tube thickness measurement analysis, Examining Mechanical properties and chemical composition of the tube material and methodologies for finding the tube failure in

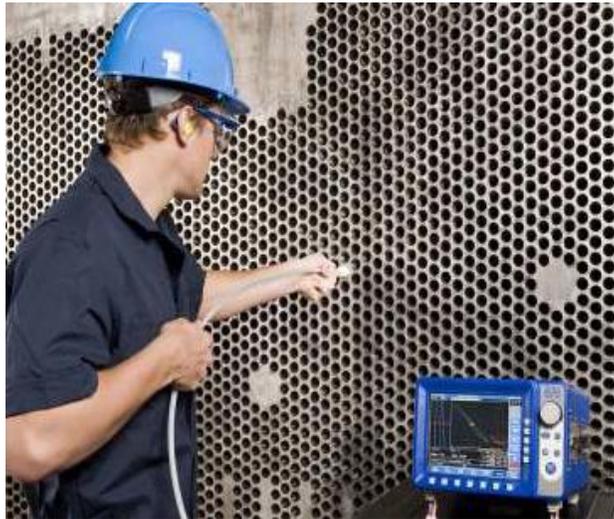
Fig.5: Eddy current test

Eddy Current Test were carried out in defective high pressure feed water heater to find the defective tubes using probes. During this test, thicknesses of the tubes were measured and weaker tubes were identified. Most of the tubes affected in De – Superheating zone area was noticed during this Eddy Current Test.

From the Eddy current test, thicknesses of the heater tubes are measured and percentages of eroded tube thickness were noticed. Also weaker tubes are identified and plugged.

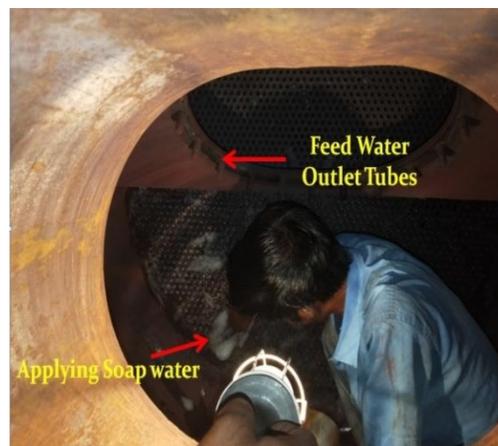
Fig.7: Soap water test

In this method air is used as working medium. Initially 0.2 kg /cm<sup>2</sup> air is to be applied on the shell side. The face of the tube sheet is covered with soap water to detect any air flowing from the open ends of a tube with a failure. If found air leak, seal off both ends of each tube using rubber stoppers. If no tube leaks are noticed, slowly increase the air pressure to a maximum of 7.0 kg/cm<sup>2</sup>. Using the Probe to locate the tube leak. Insert the probe into the leaking tube. This will seal off air flow the insertion end of the tube until the probe has been inserted far enough to reach the point of failure.

From the air leak test, it was noticed outer diameter of the tube side defects in feed water heater and also exact location of the failure occurs in the tubes were measured. Also Tube to Tube sheets defects are identified.

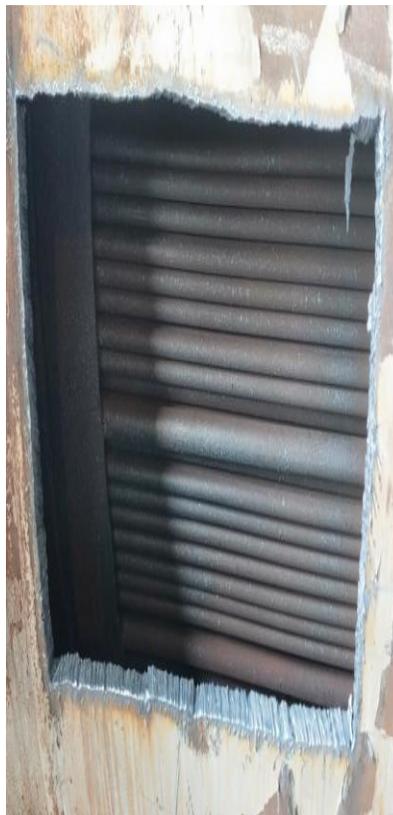
Fig.12: Feed water Heater Tube Bundles

In some types of corrosion, visual examination can suggest the cause of failure and mechanism of attack. A photograph is usually recorded for subsequent reference and comparison of defects. Corrosion pitting of steel may be present in variety forms, it caused by dissolved oxygen in the working fluid. The pitting is commonly in the form of shallow oval pits overlaid with brown.

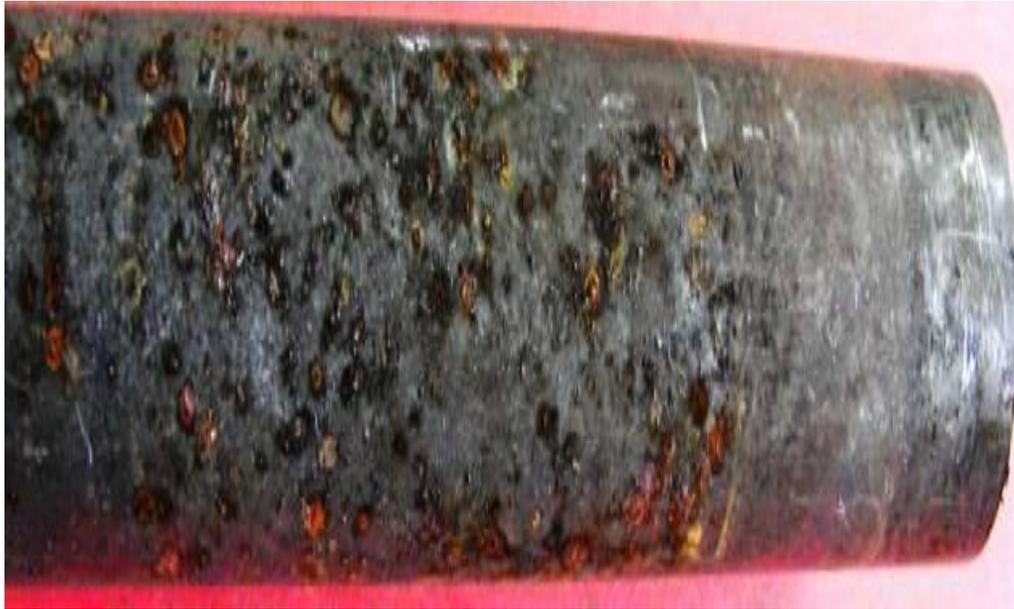
Fig.15: Degraded tube portion

From the visual inspection of the defective feed water heater tubes, most of the defects are found in the tubes in de-superheating zone and these tubes are severely affected in outer side of the tubes due to erosion and pitting problem.
